## **2008-2013 MX-5**

### **ENGINE STALL AND / OR NO START**

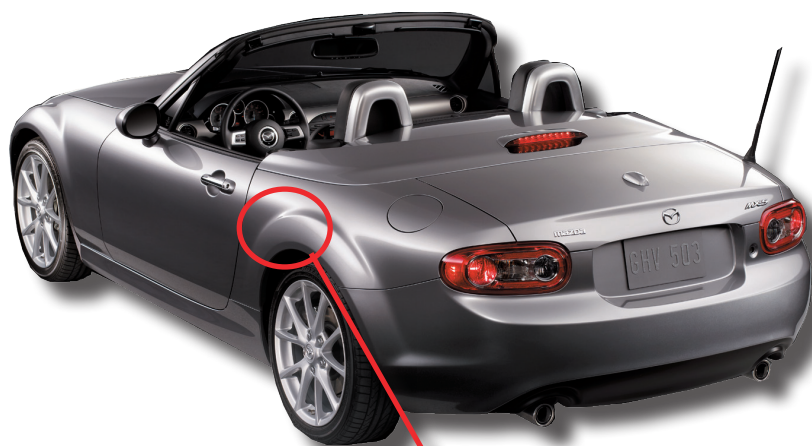
These concerns may be caused by an aftermarket electronic device (see image below).

Aftermarket electronic devices connected to the vehicle's wiring harness may interfere with the vehicle's CAN system and may cause an engine stall and/or no start condition.

**Original Factory Power Retractable Hardtop Module**

**Aftermarket Hardtop Module**

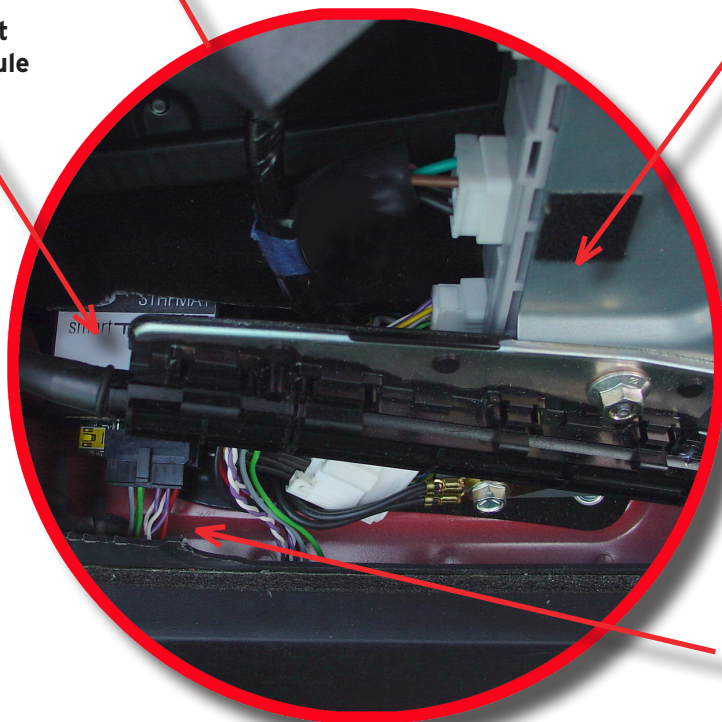
**Aftermarket Hardtop Module Sub-harness**
