2007-2015 MX-5 WITH POWER RETRACTABLE HARDTOP (PRHT)

WIND NOISE FROM DRIVER'S DOOR

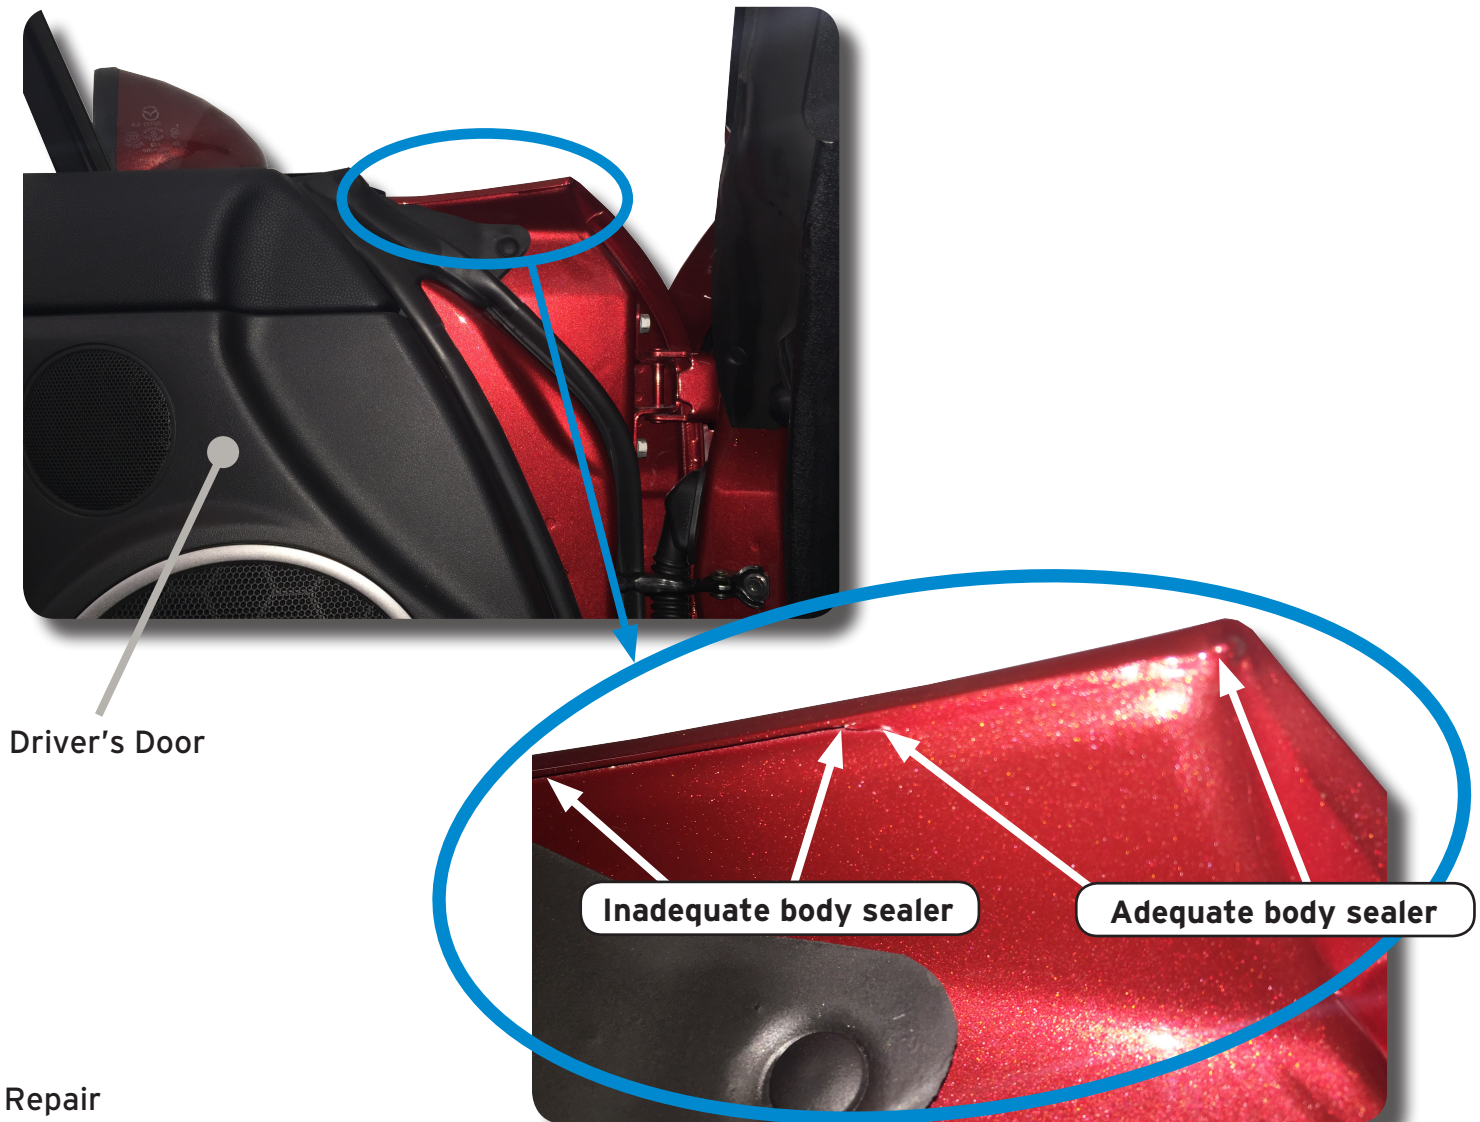
Some customers may complain about an air-/wind-type noise coming from the driver's door while driving approximately 30 mph or higher. This may be caused by poor door body sealing.

1. Inspect the area shown above.
2. If sealant is missing, add a bead of sealant to the area above showing "Inadequate body sealer".
3. Test drive the vehicle to confirm noise is no longer present.
 - a. No noise - Use vehicle color touchup paint to paint the added body sealant.
 - b. Noise is still there.
 - Check door seals
 - Check door alignment
 - Check PRHT alignment
 - Check for bent components (see M-Tip - 2008-2013 MX-5, Power Retractable Hardtop Will Not Open/Close and/or rattle-type noise)
